Manhole Inspection Summary

Manhole # **S13GG_001MH**

Insp Date: **9/18/07 11:02 AM**

Location Address: **1600 POPLAR GROVE DR**

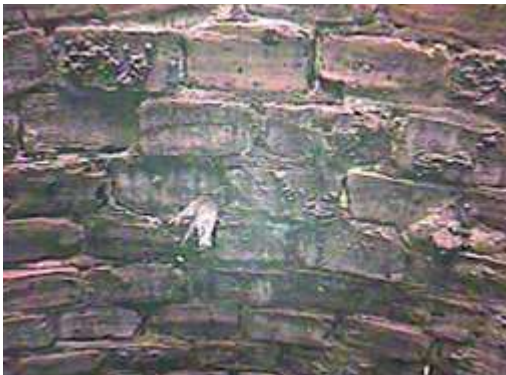
Defect 1

Count: **5** Missing: **4** ☒ **Corroded**

MISSING/CORRODED RUNGS

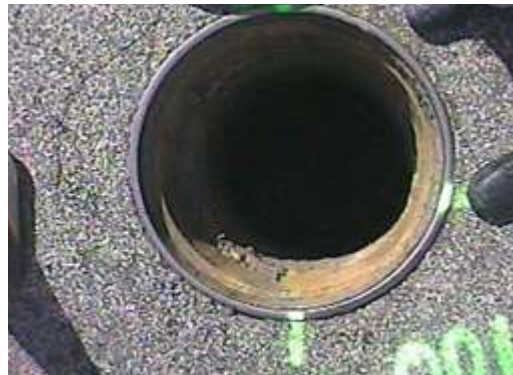
Defect 3

Offset: **2** (in.)

OFFSET FRAME

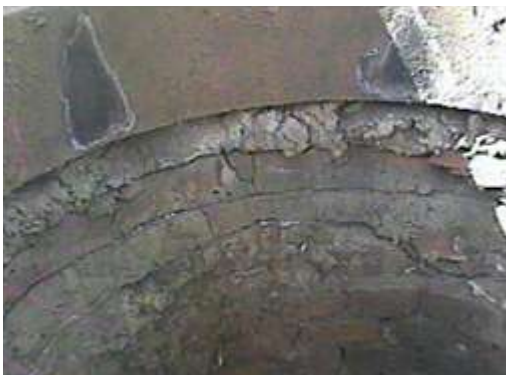
Defect 2

☒ Exists Material: **Brick and Concrete** ☐ Parged Height: **6** (in.)

Condition: ☐ Sound ☒ **Cracked** ☐ Root Intrusion ☐ Loose Brick ☐ Deteriorated

CRACKED ADJ.

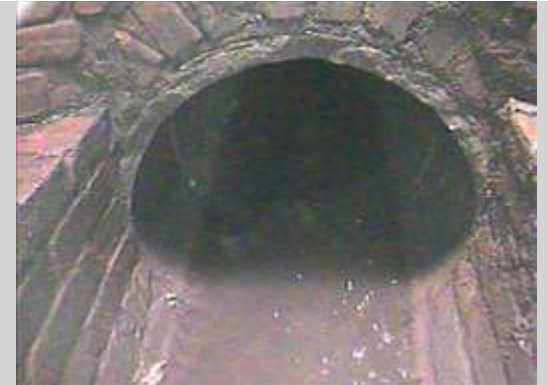
12 O'Clock Outflow

18 in. Circular Gravity Sewer
Pipe Out @ 12 O'Clock

Pipe Height: **13.2** (in.) Rod and Bar
Pipe Material: **Clay** ☐ Pipe Lined
Invert Depth: **11.62** (ft.) Flow Characteristics: **Fast**
Deposits: ☒ None ☐ Mud ☐ Sludge ☐ Debris ☐ Grease
Silt Depth: (in.) Deposits Extent:
Infiltration: **None** Pipe Seal Cond: **Broken**

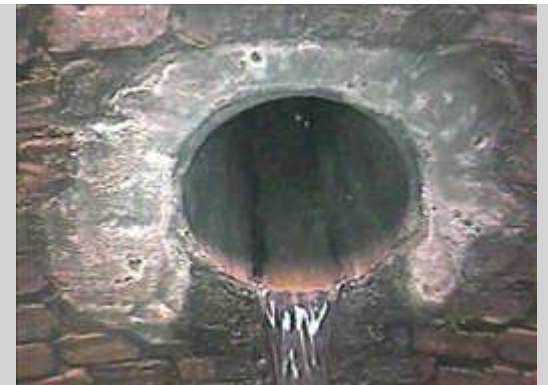
3 O'Clock Inflow

10 in. Circular Gravity Sewer
Pipe In @ 3 O'Clock

Pipe Height: **24** (in.) Direct
Pipe Material: **Clay** ☐ Pipe Lined
Invert Depth: **8.96** (ft.) Flow Characteristics: **Fast**
Deposits: ☒ None ☐ Mud ☐ Sludge ☐ Debris ☐ Grease
Silt Depth: (in.) Deposits Extent:
Infiltration: **None** Pipe Seal Cond: **Cracked**

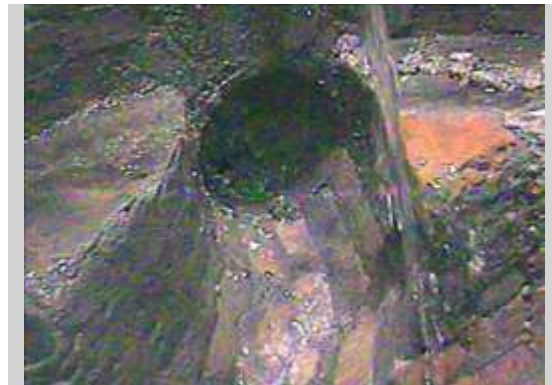
Drop In @ 3 O'Clock

Drop: **Outside Direct**
Angled: Reading: (ft.)
Inv Depth: **11.01** (ft.)
Drop Condition: **Clogged**

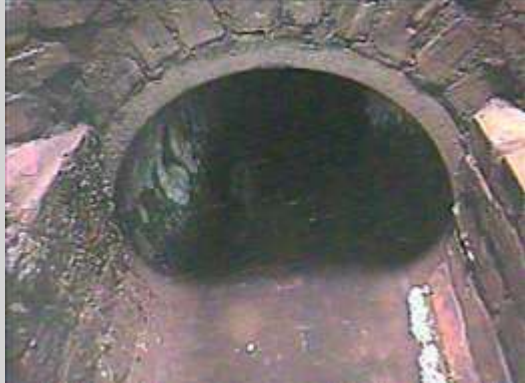
6 O'Clock Inflow

18 in. Circular Gravity Sewer
Pipe In @ 6 O'Clock

Infiltration: **None** Pipe Seal Cond: **Sound**
